RARITAN RIVER BASIN
ROCKY BROOK, MERCER COUNTY
NEW JERSEY

ETRA LAKE DAM NJ 00298

PHASE 1 INSPECTION REPORT NATIONAL DAM SAFETY PROGRAM

JULY 1981

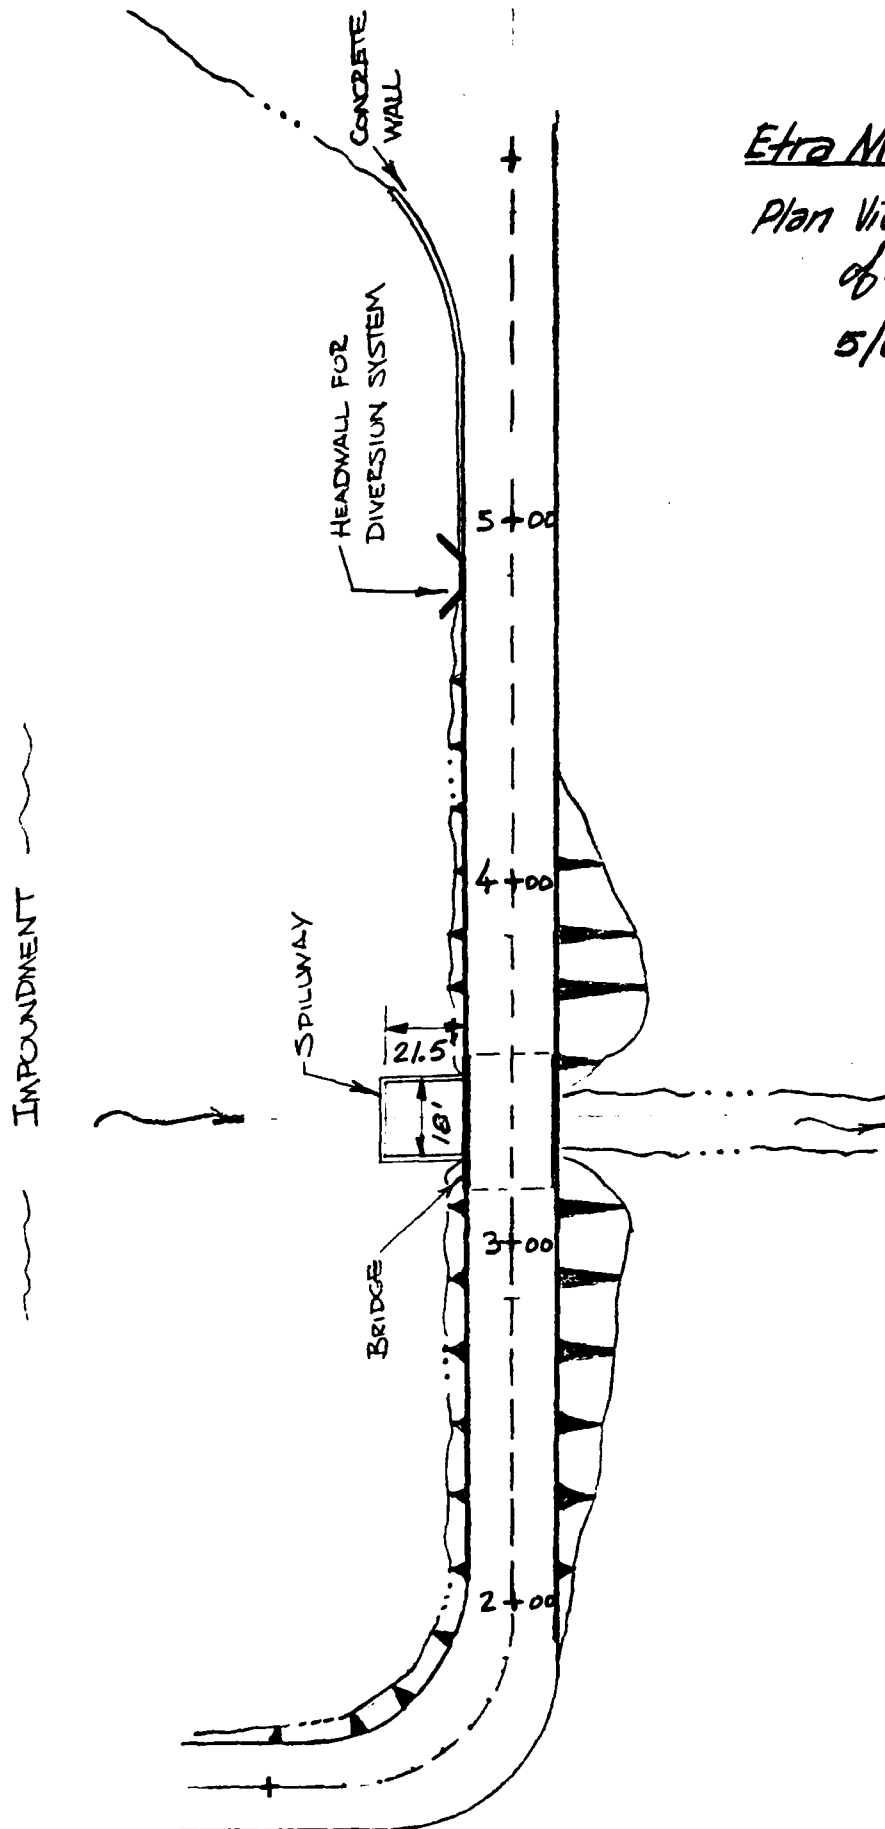
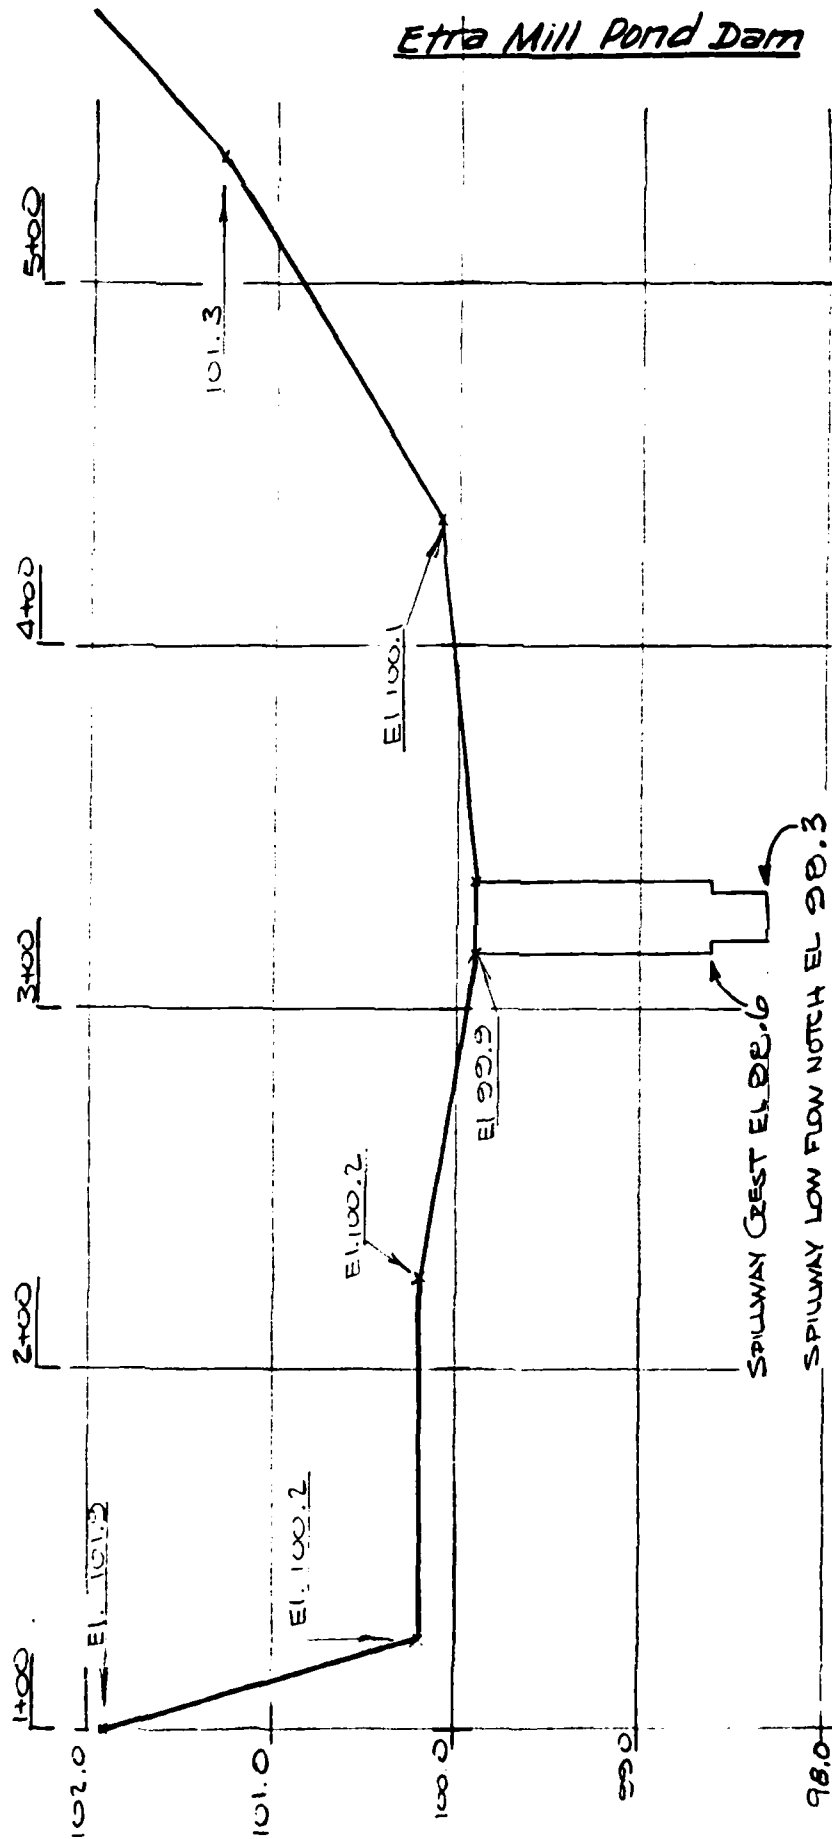
SURVEY-VERTICAL CREST ALIGNMENT
MAY 6, 1981

b. Dam. The vertical and horizontal alignment of the dam appears to be fair. No significant settlement or slope misalignment was noted. A survey of the vertical alignment of the top of the dam was made by the inspection team. The maximum variation in vertical alignment is about 1.7 feet. A sketch of the survey results is included in Appendix E, Sheet 5.
